THE Q FILES

THE SOLID FACTS ON CHRISTCHURCH LIQUEFACTION

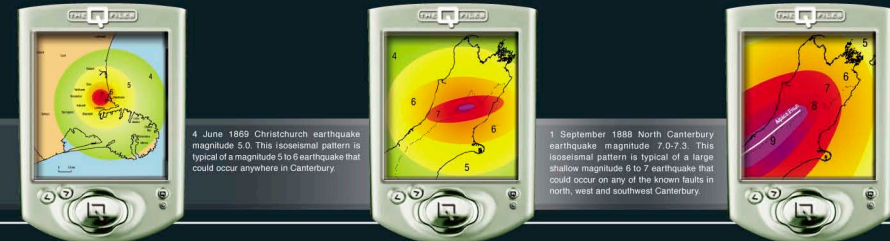
The most probable ground shaking intensities for a magnitude 6 earthquake on the Alpine Fault, which is the largest earthquake likely to occur on faults close to Canterbury.

4 June 1869 Christchurch earthquake magnitude 5.0. This isoseismal pattern is typical of a magnitude 5 to 6 earthquake that could occur anywhere in Canterbury.

1 September 1888 North Canterbury earthquake magnitude 7.0-7.3. This isoseismal pattern is typical of a large shallow magnitude 6 to 7 earthquake that could occur on any of the known faults in north, west and southwest Canterbury.

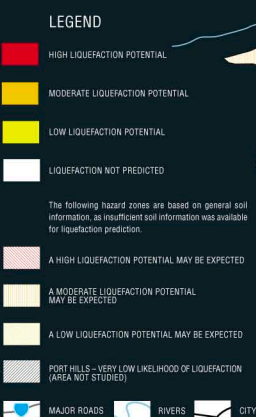
B HIGH GROUNDWATER TABLE LIQUEFACTION POTENTIAL HAZARD MAP

The water table level varies across Christchurch, and also varies considerably during the year and from year to year. The high groundwater table liquefaction potential hazard map (B) represents average to high groundwater conditions. The low groundwater table liquefaction potential hazard map (A) is based on January averages for the last ten years.

HIGH LIQUEFACTION POTENTIAL
Areas of Christchurch rated as having "high liquefaction potential" have soil types and strengths that are the most prone to liquefaction. Three types of earthquakes could cause liquefaction in these areas - a foothills earthquake, a foothills earthquake and an Alpine Fault earthquake.

LOW LIQUEFACTION POTENTIAL
Areas of Christchurch rated as having "low liquefaction potential" have soil types and strengths that are the least prone to liquefaction. Only an Alpine Fault earthquake could cause liquefaction in these areas.

LIQUEFACTION NOT PREDICTED
Areas of Christchurch rated as "liquefaction not predicted" are areas where expected ground shaking intensities are unlikely to cause liquefaction. These areas may contain liquefiable soils or could be subject to settlement or ground fissuring as a result of ground shaking itself, and not liquefaction.
